Maintenance Guide
Inner Swell Beveling Machines

Inner Swell Beveling Machine Manual

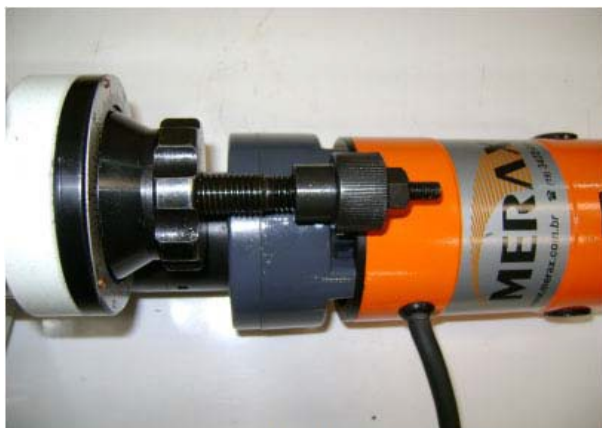
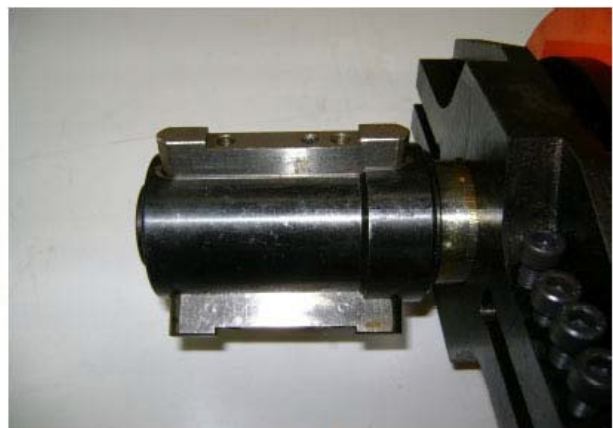
Do not try to expand clamping chucks beyond their limits or deregulation may occur. **(Fig. 1 and 2)**

- Clamping chucks will not retract or retraction is difficult: rings spring without pressure (expect in models ISY TCM 28 e 150). Check and replace. **(Fig. 2)**

- If clamping chucks limits deregulate, move ring springs and chucks. Put the expansion nut back in the lowest limit, and simultaneously

adjust clamping chucks on support until clamping chucks faces support.
(Fig. 2 and 11)

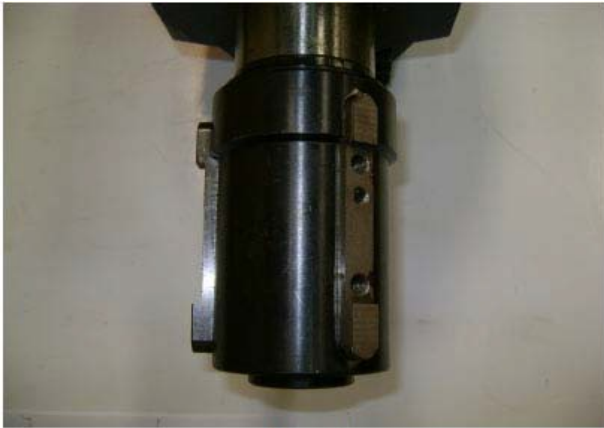
Fig. 3

Keep equipment clean, and expansion and feed shafts, and clamping chucks lubricated. Pay special attention to model ISY/TCM 150, checking if clamping chucks screws are tight. **3, 4 and 12)**

- When clamping chucks get stuck, i.e., do not expand, possible causes are: damaged clamping chuck or support. Replace. **(Fig. 3)**

- Dirt or scrap on support: clean. **(Fig. 3 and 11)**

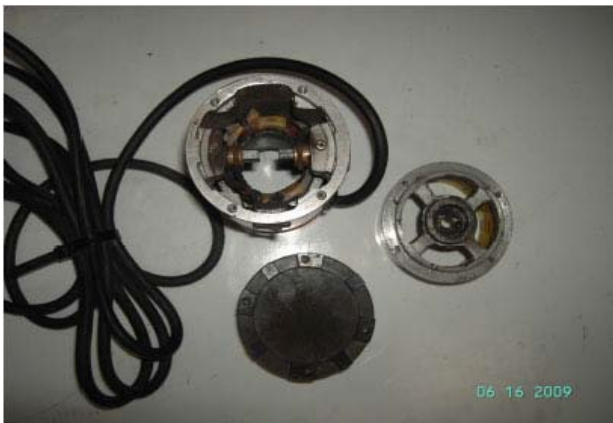
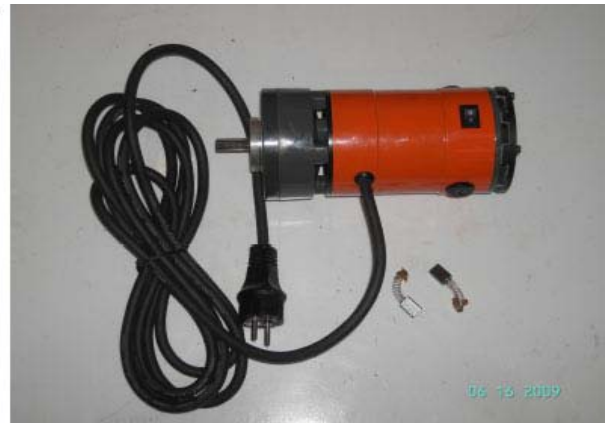
Electric motor: electric motor stop - check coal brushes, power cables and replace damaged parts, if necessary (**Fig. 5 and 6**)

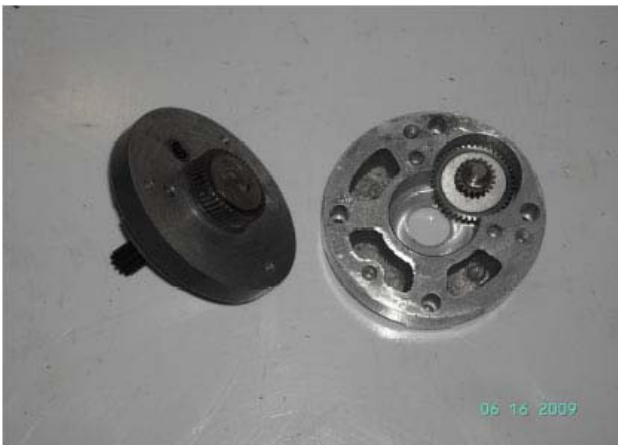
Fig. 7

- Noise in motor reducer - check bearing and gear set. Replace damaged parts. **(Fig. 7)**

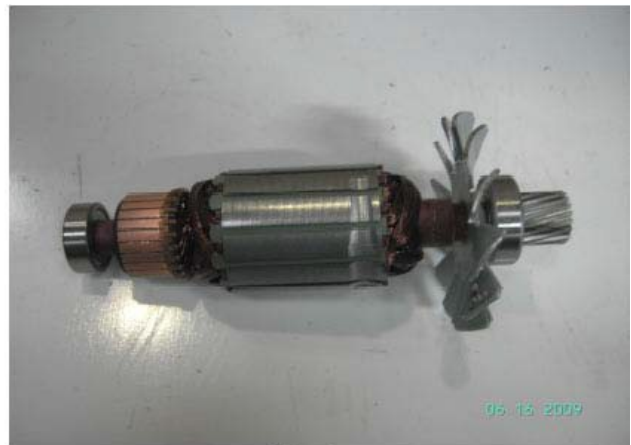
Fig. 8

- Loud motor noise - possible bearing break-down Check bearing and other motor parts and replace damaged parts. **(Fig. 8).**

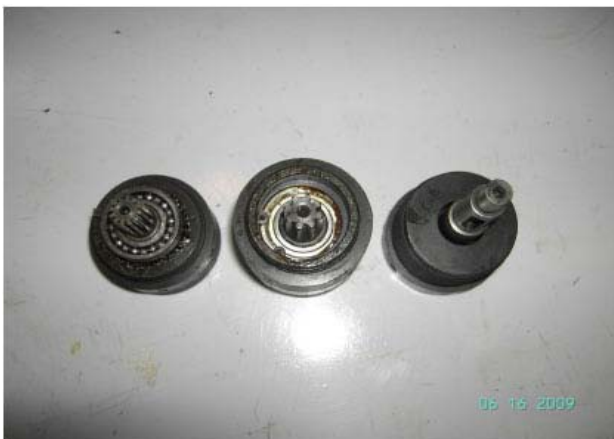
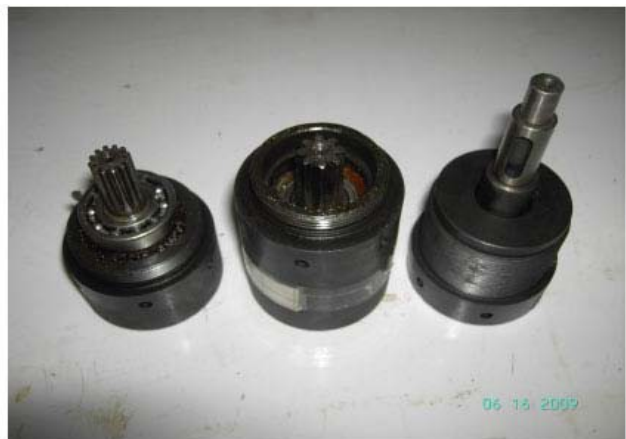
- Reducer planetary - electric drive of motor occurs, but machine does not work. Planetary shafts or bearings (3) may be damaged. Replace damaged parts. **(Fig. 9 and 10)**

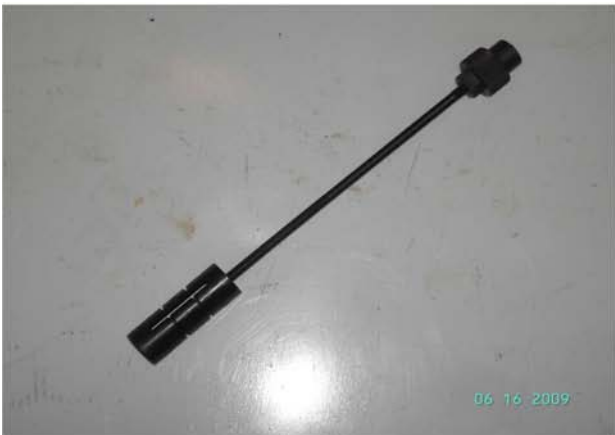
Fig. 11

- Does not expand - check expansion shaft and expansion shaft nut. Replace, if necessary. **(Fig. 11)**
